# **Rhopoint ID Application Notes**

## SURFACE ROUGHNESS AND BULK SCATTER

#### **Overview**

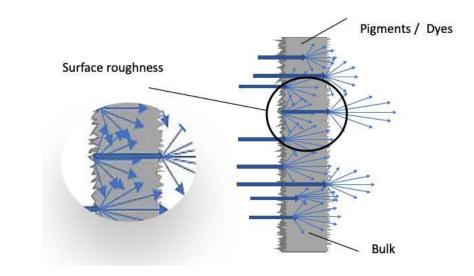
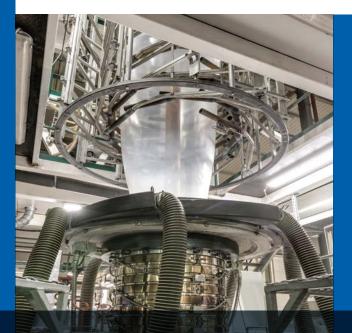
The extrusion process for making blown polyethylene film and bags starts with pushing the molten plastic through an annular slit die to form a continuous thin walled tube of plastic called a bubble.

2 The bubble is inflated with air to the desired diameter and drawn vertically up a tower through a high-speed air ring which cools it before passing through nip rolls where it is flattened to its lay-flat width.

**3** The collapsed lay-flat tube is then transported back down the tower by external rollers. The thickness of the film is controlled by the speed at which it is pulled from the die. The width of the film is controlled by the amount of air that is inserted in the bubble. As blown film freely flows during the process surface roughness is mainly caused by the melt-flow characteristics and crystallization of the material during cooling.

4 It is therefore essential that in-process controls are optimised to ensure consistent product quality; the surfaces of the slit dies and chill rollers should be consistently free from wear or damage and the plastic melt homogeneity, blow-up ratio and cooling rate should be correctly controlled.

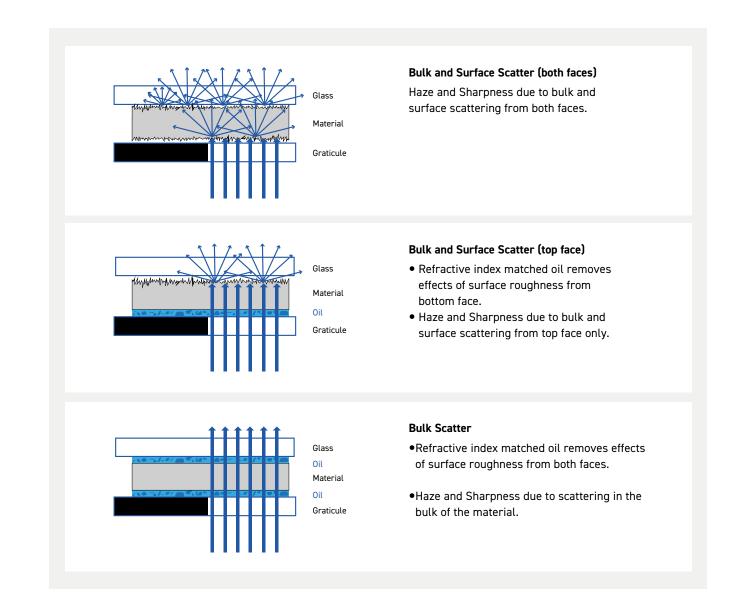
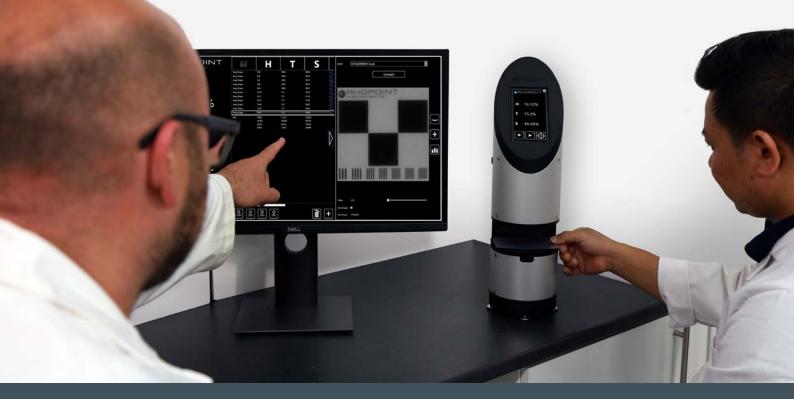
## Rhopoint ID method for isolating bulk and surface scatter

To improve processes or materials it is useful to identify exactly where the reduction in optical quality originates. The ID Surface roughness test can isolate and measure the effects of surface roughness on each side as well as the effects of bulk scatter in the material.

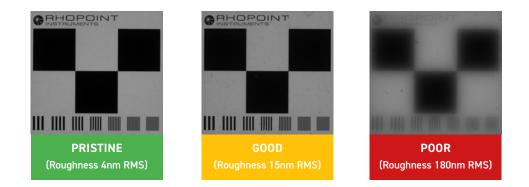
#### PROCESS Example – PMMA Film roughness

**STEP 1**: Three different samples of 0.25-mm-thick PMMA chemically etched film were used to simulate the effects of surface roughness. Each sample was tested using Rhopoint ID-L.

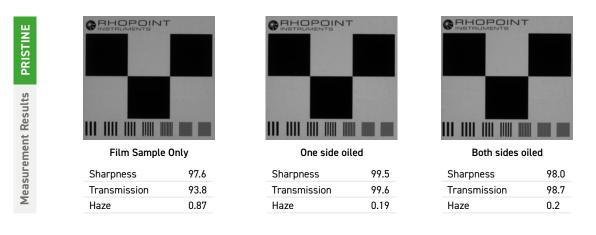
**RESULTS** Example – PMMA Film roughness

With oil applied to both sides of the **PRISTINE** sample the haze value reduced slightly indicating that there was almost no surface roughness present. Transmission and Sharpness values were consistently high.

As the etched film samples tested were produced from the same material there was no noticeable change in the Sharpness value of the oiled material measurements indicating a consistency in bulk properties.

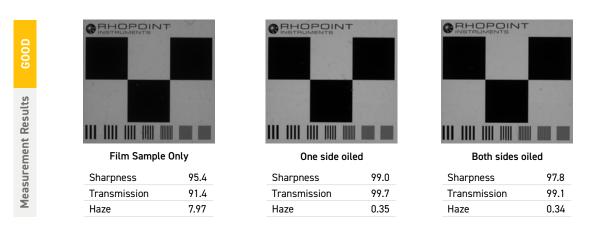
The Haze value for the <u>GOOD</u> film sample only was high and with oil applied to one side this dropped significantly indicating that surface roughness was present. When applied to the other side there was no change to the haze value. Sharpness and Transmission were consistently high.

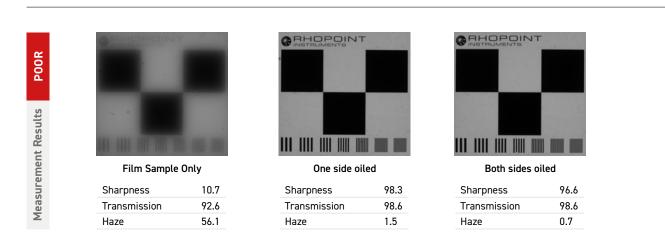
The haze value for the **POOR** film sample only was very high and with oil applied to one side this dropped significantly indicating surface roughness was present on this side. Sharpness also increased. With oil applied to the other side the haze value dropped further indicating that there was a much smaller amount of surface roughness present.

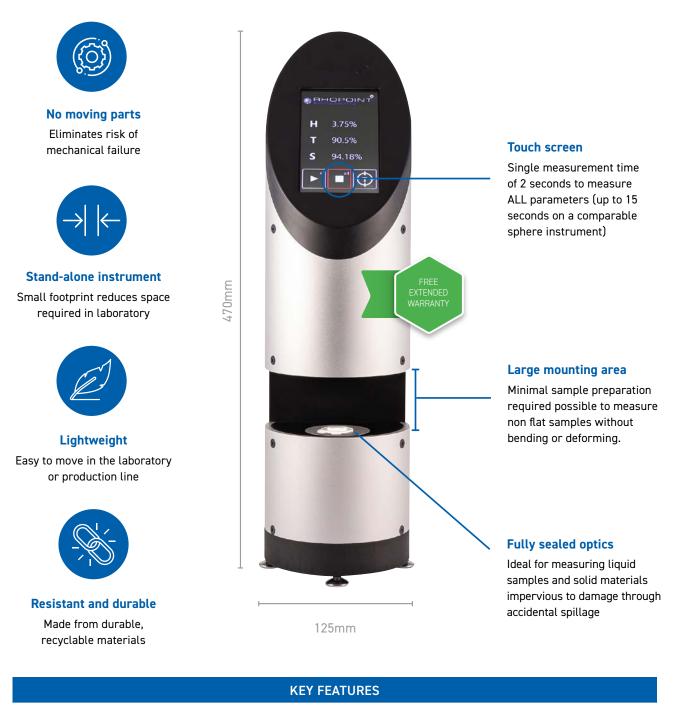
## Features of the Rhopoint ID

- $\checkmark$  Analysis / detection of surface roughness caused by in-process failure
- $\checkmark$  Measured data and images allow visual confirmation of potential surface issues
- $\checkmark$  Sample movement between measurement ports not required
- $\checkmark$  Isolating each surface side identifies roughness and defects caused by manufacturing process
- $\checkmark$  Greater amount of information available for identification and reporting purposes
- Easy to use and clean, use of vertically mounted oil filled cuvettes not required
